Manhole Inspection Summary

Manhole # S45G2_012MH

Insp Date: **1/10/08 12:18 PM**

Location Address: **1500 Olmstead-Locust**

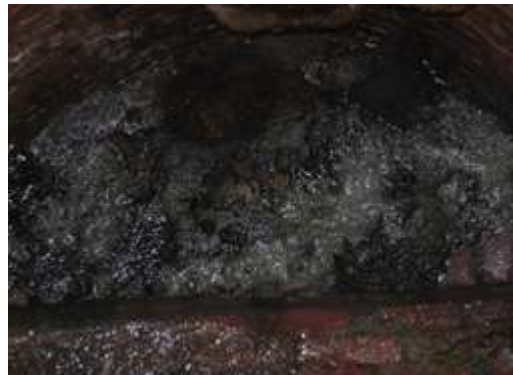
Defect 1

Waste on bench

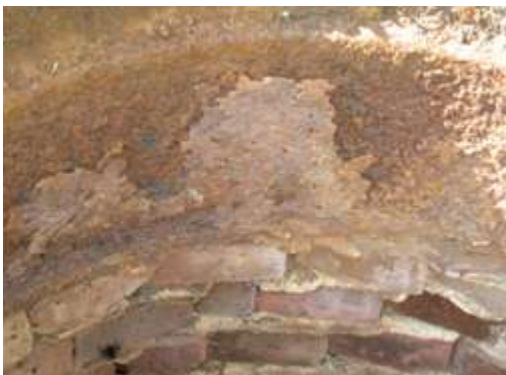
Defect 2

Corroded frame

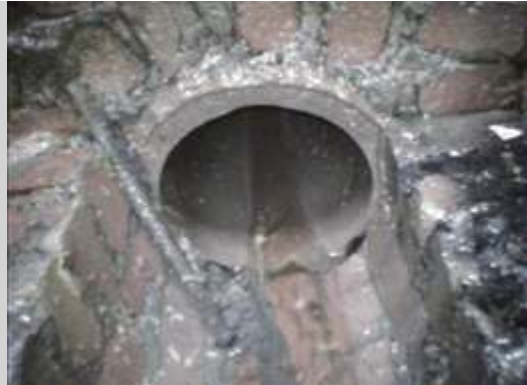
12 O'Clock Outflow

8 in. Circular Gravity Sewer
Pipe Out @ 12 O'Clock

Pipe Height: **9.6** (in.) Rod and Bar (Angled)
Pipe Material: **Clay** ☐ Pipe Lined
Invert Depth: **10.83** (ft.) Flow Characteristics: **Fast**
Deposits: ☒ None ☐ Mud ☐ Sludge ☐ Debris ☐ Grease
Silt Depth: (in.) Deposits Extent:
Infiltration: **None** Pipe Seal Cond: **Sound**

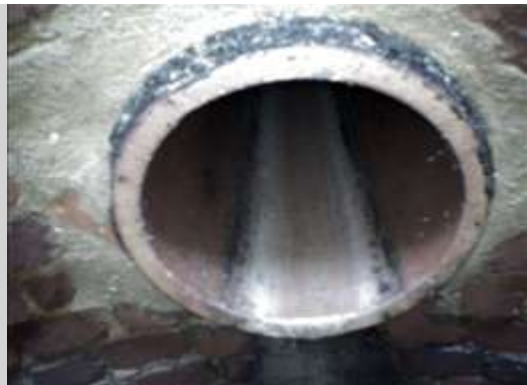
6 O'Clock Inflow

8 in. Circular Gravity Sewer
Pipe In @ 6 O'Clock

Pipe Height: **12** (in.) Rod and Bar (Angled)
Pipe Material: **Clay** ☐ Pipe Lined
Invert Depth: **6.85** (ft.) Flow Characteristics: **Fast**
Deposits: ☒ None ☐ Mud ☐ Sludge ☐ Debris ☐ Grease
Silt Depth: (in.) Deposits Extent:
Infiltration: **None** Pipe Seal Cond: **Sound**

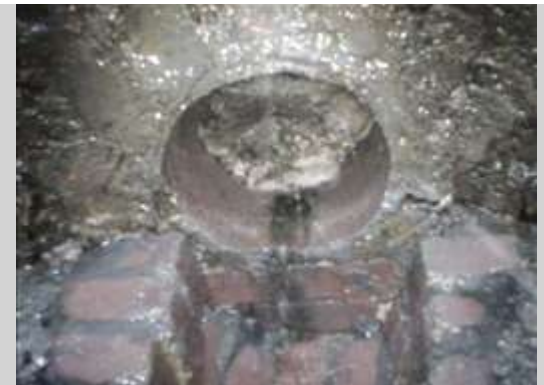
Drop In @ 6 O'Clock

Drop: **Outside** Rod and Bar
Angled: **Yes** Reading: **8.46** (ft.)
Inv Depth: **9.46** (ft.)
Drop Condition: **Open**

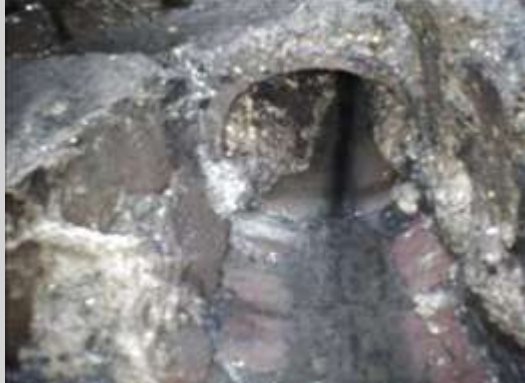
7 O'Clock Inflow

8 in. Circular Service Sewer

Pipe Height: **8.4** (in.) Rod and Bar (Angled)

Infiltration: **None**

Pipe Seal Cond: **Sound**
